*Source Control Evaluation  
Operable Unit 1  
Swan Island Upland Facility  
Portland, Oregon*

Prepared for:  
Port of Portland

February 20, 2013  
1115-06

Ash Creek Associates  
A Division of Apex Companies, LLC

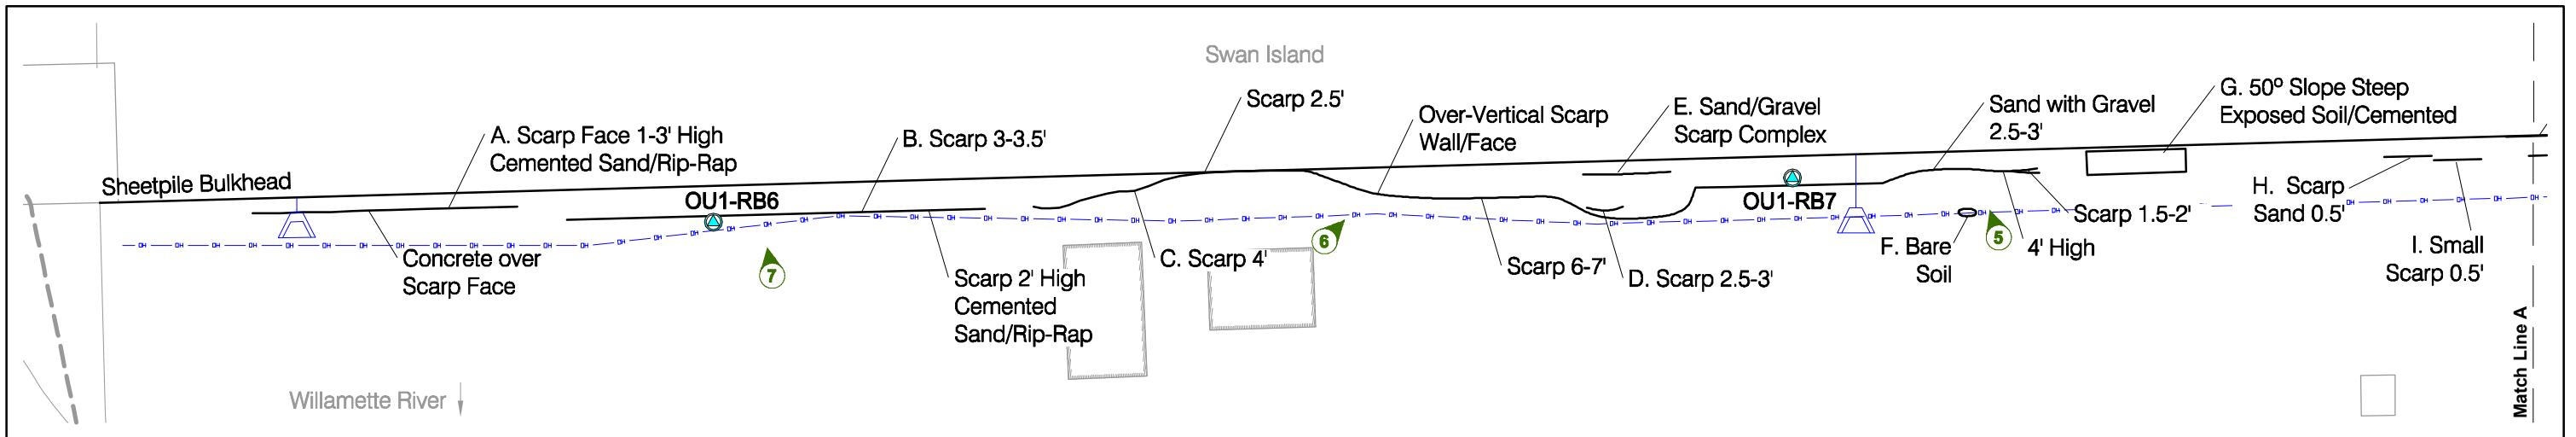
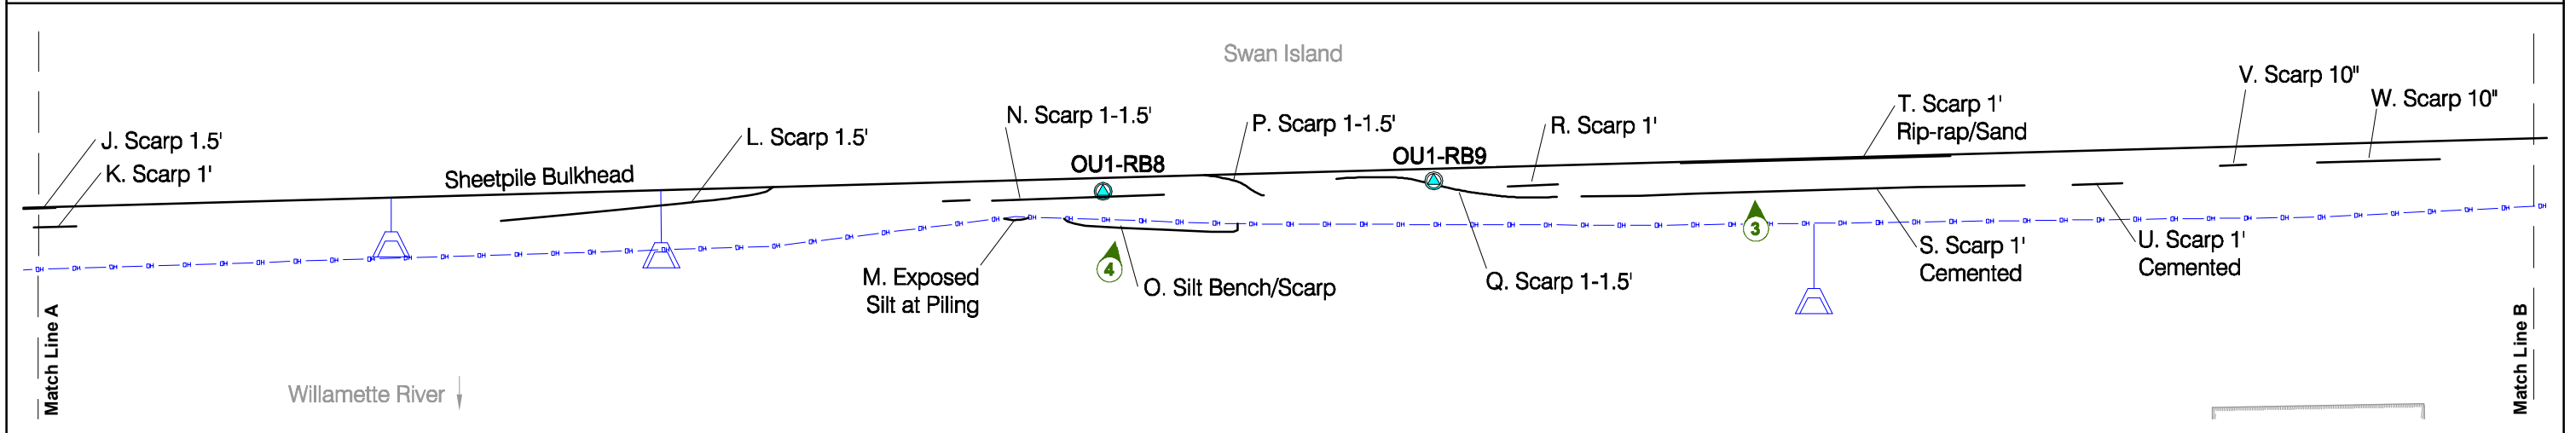
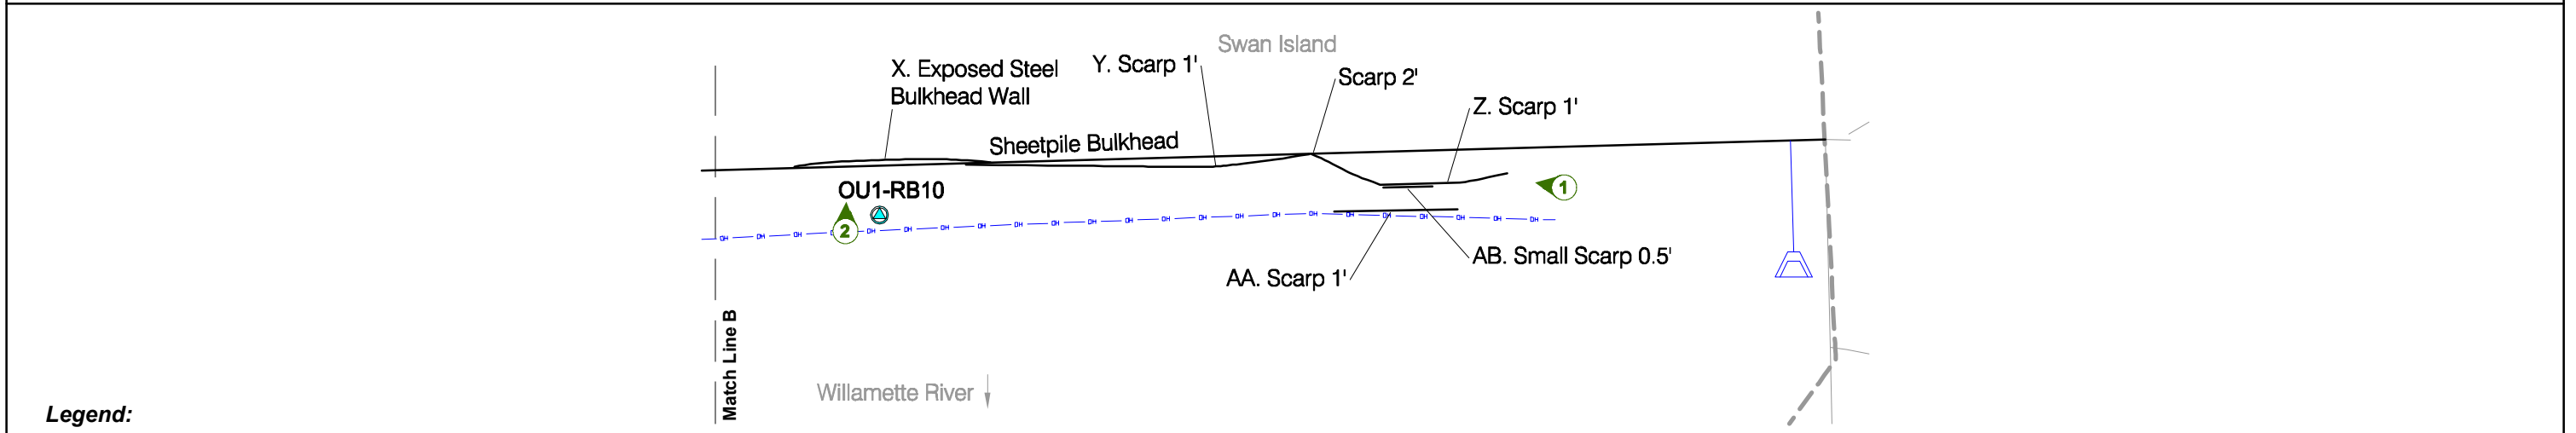
<h2>River Side Docks</h2> <p>Source Control Evaluation Swan Island Upland Facility Operable Unit 1 Portland, Oregon</p>

There was a single line of evidence of erosion beneath the wharf structure. The riverbank is covered with rip rap, but high on the slope were observed erosion scarps. These scarps are normally above the river level and are protected from overland flow from the overlying wharf. These scarps could be subjected to potential wave action during infrequent high water levels. Five soil samples were collected from observed historical erosion features. One to four metals (cadmium, copper, lead, and mercury) were detected at least once above SLVs in each sample, but ERs were 5 or less in four of the samples, and the maximum ER was 8, for mercury. TBT was detected in two of the five samples, but the maximum ER was less than 2. PCBs were not detected in two of the five samples. Where detected, the ER for total PCBs ranged from 12 to 380. Cadmium, lead, mercury, PCBs, and TBT are bioaccumulative COI. Nickel, TBT, and PCBs were detected above EPA focused PRGs in sediments adjacent to this area. PCBs exceeded only the Background Hilltop PRG. The inconsistent soil/sediment results – nickel above the PRG in sediments but below default
